UPDATE ON THE OCURRENCE OF THE SOIL LIQUEFACTION PHENOMENON IN PERU

Jorge Alva-Hurtado¹

, Carmen Ortiz-Salas^{1*}

¹ Graduate School of Civil Engineering, National University of Engineering, Lima, Peru

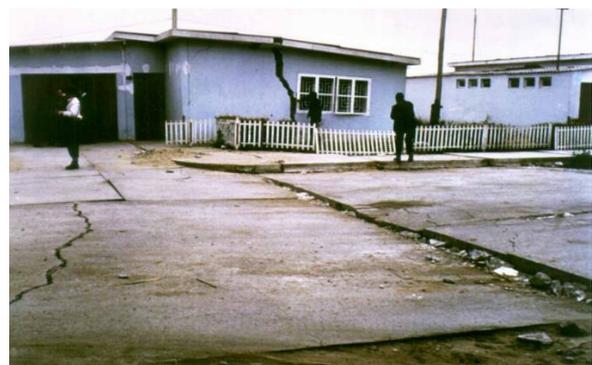
The largest areas of sand boils formed along the Casma river, between Casma and the Port of Casma. The central crater of the volcanoes measured from several centimeters to 1 m in diameter, surrounded by a mound of sand and silt of up to 15 m in diameter. There were also jets of water reaching a height of up to 1 m. Soil liquefaction was evident in Chimbote's central area, as was the differential compaction of the foundation. The Casma bridge was damaged due to the liquefaction of the foundation of the abutments. Liquefaction-induced ground subsidence could be observed in Chimbote, Casma and along the Pan-American Highway. The residential area of the Port of Casma showed evidence of settlement and water ejection. Cluff [14] reports ground failure in Chimbote due to saturated and loose beach deposits. Liquefaction-induced lateral spreading and differential compaction also occurred in Casma (Fig. 1).

Fig. 1. Concrete-block house affected by differential compaction and lateral spreading due to the liquefaction of beach sand.

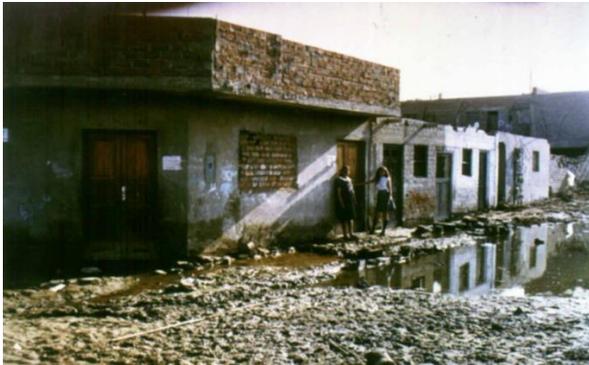
Differential compaction caused the land to be flooded by groundwater (Fig. 2). Sand boils and water ejections appeared in many areas because of the high-water table. Berg and Husid [21] report evidence of soil liquefaction in the foundation of the Mundo Mejor school in Chimbote. Carrillo [22] points to the settlement of the access embankments of almost all the bridges along the Pan-American Highway, as well

Fig. 2. Flooding of area in southeast Chimbote due to settlement and soil compaction.

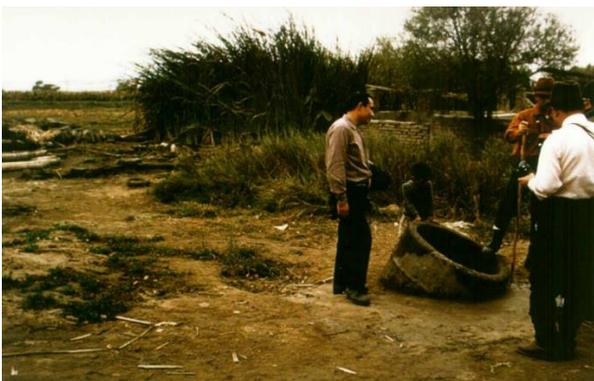
Fig. 3. Damage to sewer inlets due to liquefaction

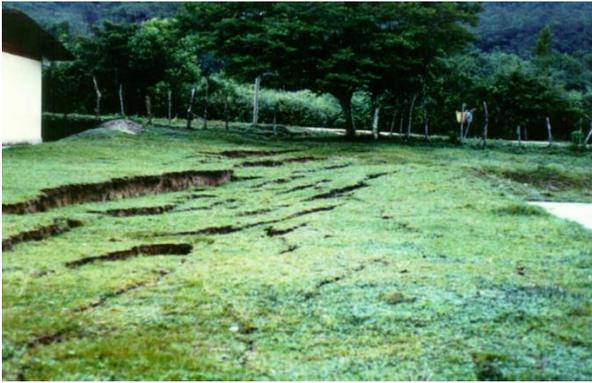
Alva [32] observes and describes the soil liquefaction phenomenon at the Port of Tahuishco in Moyobamba. Lateral spreading due to liquefaction occurred at the Educational Center of Tahuishco in 1991, creating cracks 10 cm wide and 50 cm deep (Fig. 4). The floor of a classroom was destroyed. During the 1990 earthquake, the phenomenon did not reach the school building, but it did reach its courtyard where sand boils appeared.

Fig. 4. Ground cracking near the Tahuishco school due to soil liquefaction

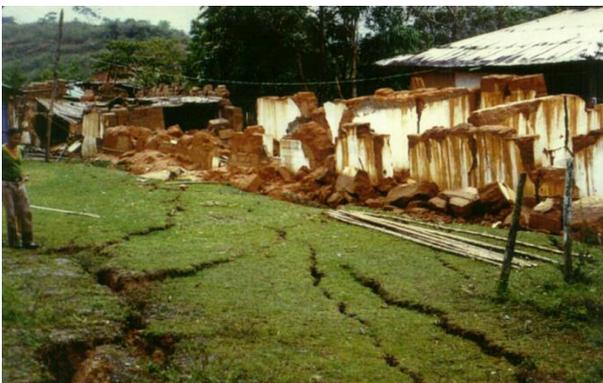
Ground cracking and lateral spreading occurred in Azunge, located in the Moyobamba lowlands. Cracks were reportedly 100 m long, 40 cm wide and 1 m deep. Most of the houses on the slopes collapsed. The pumping station and sewer lines failed. All the mudwall houses and a few brick houses built on soft ground collapsed (Fig. 5).

Fig. 5. Damage to mudwall houses and ground cracking due to lateral spreading in Azungue.

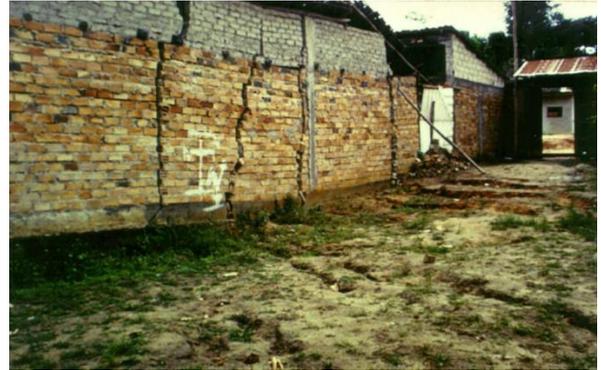
In Shango, mudwall houses collapsed. 80-cm-long cracks with a 20 cm slope were observed (Fig. 6). Along Miraflores street, cracks were 30 m long and had a depth of 30 cm.

Fig. 6. Ground cracking due to liquefaction going through a brick wall in Shango

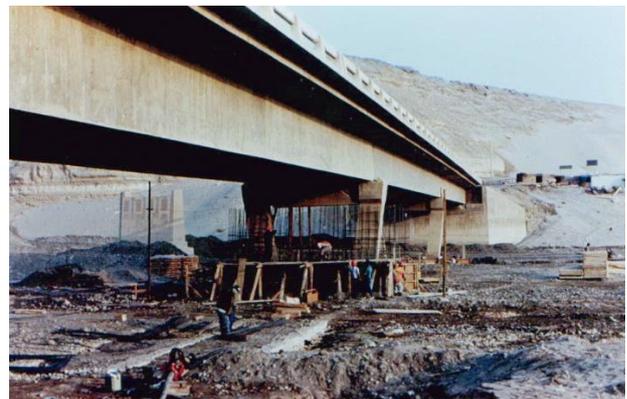
Alva and Vasquez [33] indicate that soil liquefaction occurred along the riverbed of the Yauca river, as did sand boils, mud ejections and cracking. Cracks opened on the top beam and column of one of the bridge's pillars, and the board was displaced. Traffic was interrupted and bridge repair and restoration works began immediately (Fig. 7).

Fig. 7. Soil liquefaction in the foundation of the Yauca Bridge

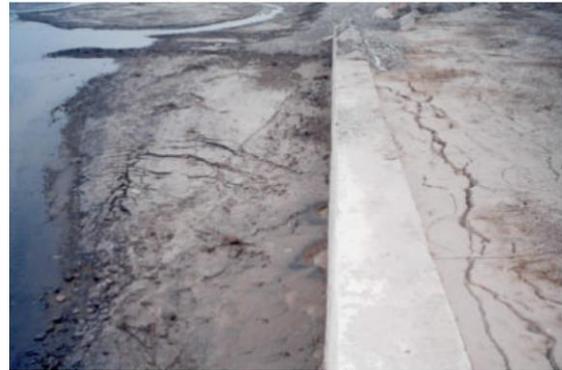
Fig. 8. Containment wall pulled into the abutment of the bridge over the Sama river

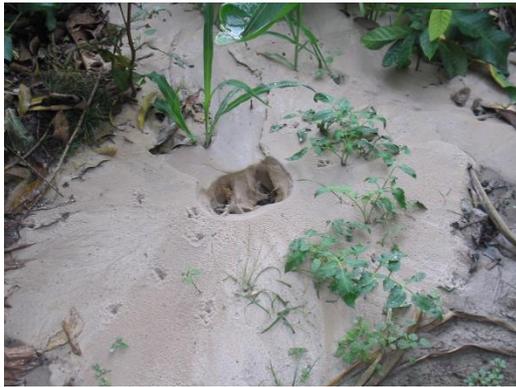
Fig. 9. Sand boils, city of Moyobamba

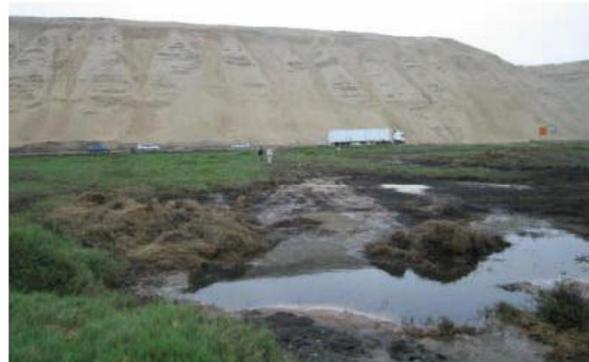
Slope failure in Jahuay: The 400-m long, liquefaction-induced failure in Jahuay occurred at the foot of a steep slope, approximately 30 to 50 m in height. It occurred near kilometer 188 of the Pan-American Highway (Fig. 10), just south of the toll booth (approximately 40 km from the rupture plane). Sand DOI: <https://doi.org/10.21754/tecnia.v30i2.756>

Fig. 10. 400-m slope failure along the Pan-American Highway

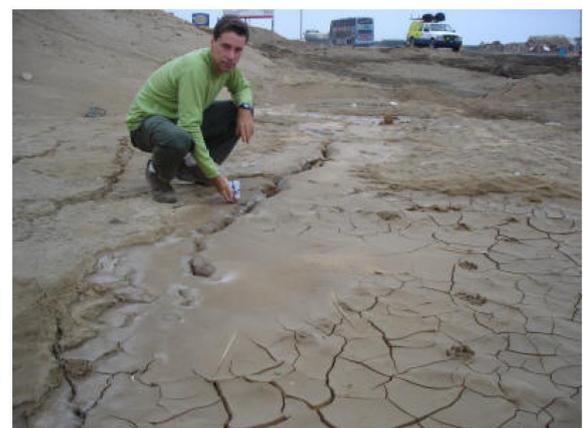
cones were found on either side of the highway and a person living just south of where the landslide occurred reported large quantities of water and sand ejecting from the ground during the earthquake, reaching heights of up to 1 m. A sand cone found at the southern tip of the slope failure had contraction cracks in the perimeter material, indicating the presence of fine plastic (Fig. 11).

Fig. 11. Large sand cone with possibly liquefied fine grains.

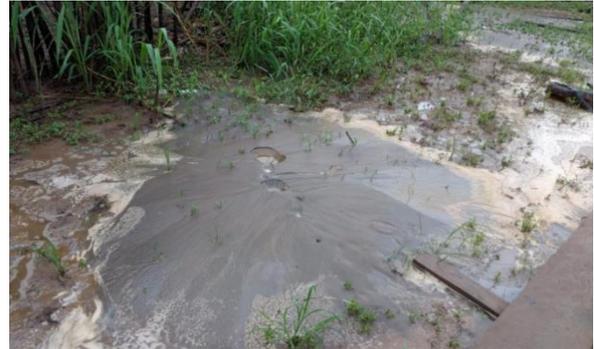
There were problems given the soil liquefaction phenomenon, with evidence of sand cones and lateral spreading with cracks along the Huallaga river pier (Fig. 12), at the "El Sauce" Resort (Fig. 13), in the town of Tamarate (Fig. 14), near the Lagunas district and in the 2 de Mayo hamlet in San Martín, Rengifo [40].

Fig. 12. Sand cones found along the pier of the Huallaga river, in the district of Lagunas, province of Alto Amazonas, Loreto.

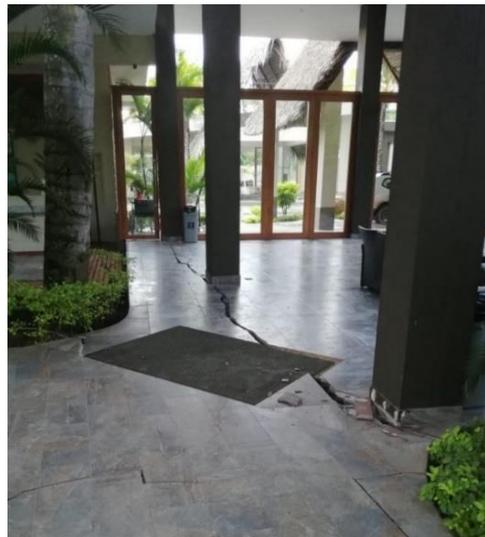
Fig. 13. Lateral spreading with cracks at the "El Sauce" Resort in Tarapoto
