SEISMIC STRUCTURAL ASSESSMENT OF A 40 YEARS OLD MELT SHOP FACILITY

Guillermo HUACO^{1*}, Waldo INGA ¹, Audry CAMACHO²

² HATCH PERU, Lima, Peru.

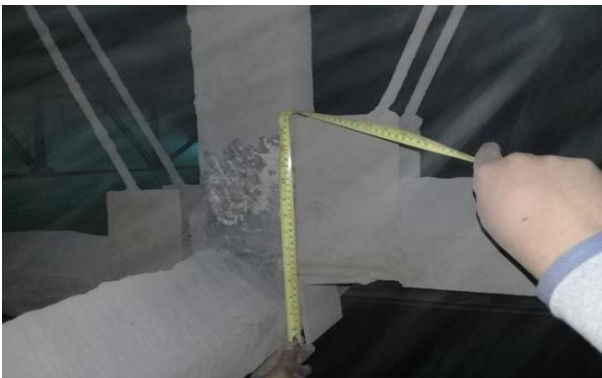
The connections of the Truss Type I are made by gusset plates and angular shapes. These are wrapped in metallic dust as can be seen in Figure 4 and the layer of paint on top of the surface, angles shapes, connections and plates; they are detached.

Figure 4. Connection welded with plates typical in Truss Type I (Source:Own)

Maintenance of the steel roof should be applied. Removing the metal dust will reduce the existing weight on the steel shapes. Besides it is necessary to reinforce the steel members, adding lateral braces is an option.

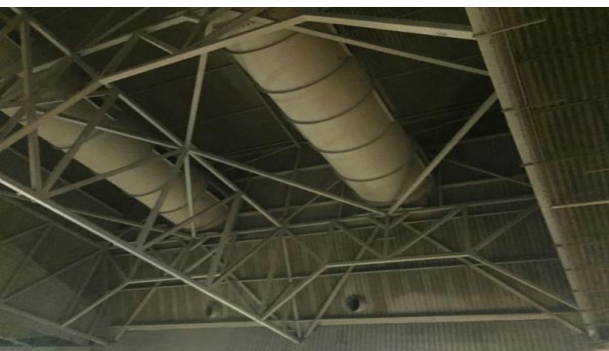
For the connections of the Truss Type II and III formed by square and rectangular hollow shapes, the connection is welded all around. There is metallic dust which is accumulated on the surface of the steel shapes. See Figure 5

Figure 5. Views of the roof between Axis 8 and Axis 5 and support of gas pipes on top of the metal sheds for Truss Type II and III (Source:Own)

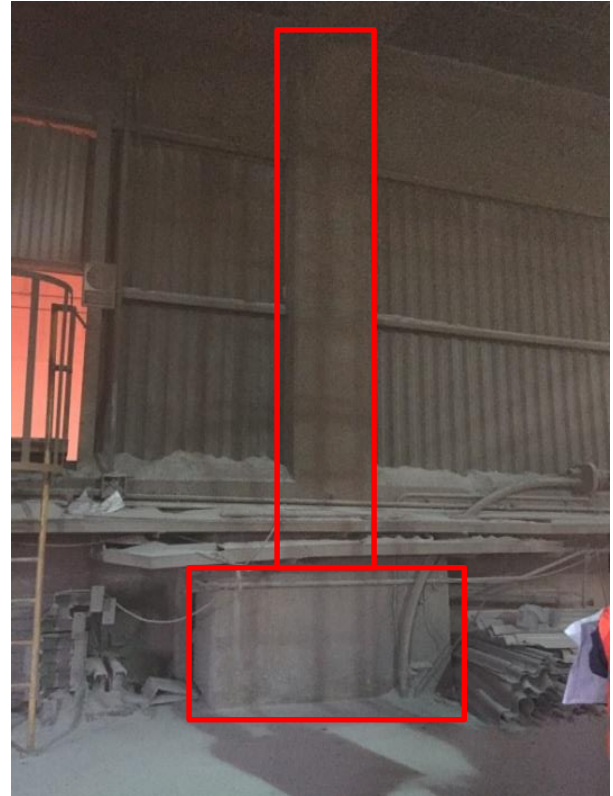
Figure 8. Column damaged on axis C / 3 Level 0.00. (Source:Own)

Considering the location near the sea, the moisture due environment, the loss of coating in the elements of reinforced concrete produces rust on the reinforcement, which along time can lose cross section and consequently its structural capacity will be reduced. For the structural analysis, the condition of the elements was taken account and the demand in the damaged elements was assessed.

It is necessary repair local damage on concrete members where spalling of cover and rust on reinforced are presented. As well it is necessary to retrofit the columns and beams which demands are higher than capacity of bending and shear. Under the heavy loads from the 3 cranes is OK the concrete frames, however due seismic loads the columns and beams might fail. Using CFRP is one alternative for retrofit.

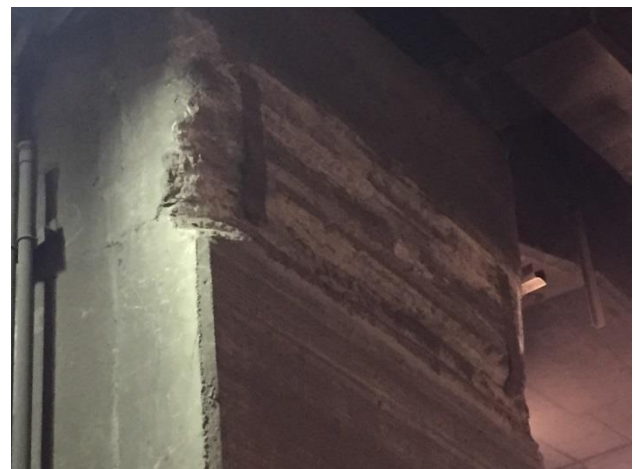
During auscultation of the reinforced concrete frames, the measurements of the original plans and the current condition of the element were observed and verified. It was found that some columns have cross sections with significant changes at half height (Figure 8), others with spalling of the cover, in addition to blows or possible friction caused by external agents (Figure 9), and total fall of coating and exposure of the internal reinforcement (Figure 10) which is rust can be noticed.

Figure 9. Column in intersection of X axis and 7 axis in Level +19.00. Significant change of cross section is observed (Source:Own)

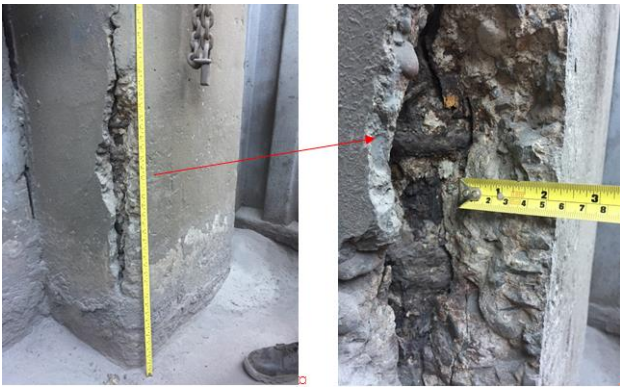
Figure 10. Column damaged on axis C / 3 Level 0.00. (Source:Own)

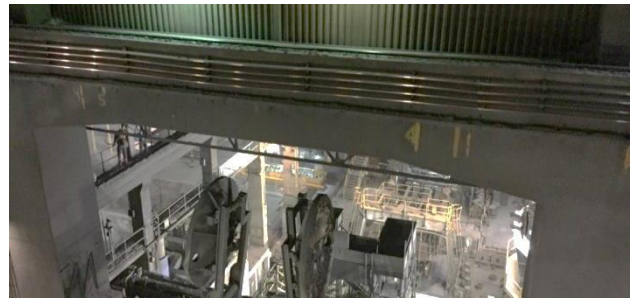
One of the beams where greater emphasis was placed on auscultation was the track beam on Axis C, which loads the heavier cranes, 130tn and 80tn. The section shown in Figure 12 shows the beam with brackets between the axles C / 6 and C / 7. It was observed that the beam has metal plates attached to one side of this and mortar stuck in the bottom. These surfaces were cleaned manually and cracks from 0.20mm to 0.50mm could be noticed, which are not indicative of structural damage. No greater damage is observed in these, only the presence of metallic dust produced by the yielding of metal, as well as some scratches that could occur. with friction of mechanical equipment.

Figure 12. Rail beam between axles C / 6 and C / 7 (Source:Own)

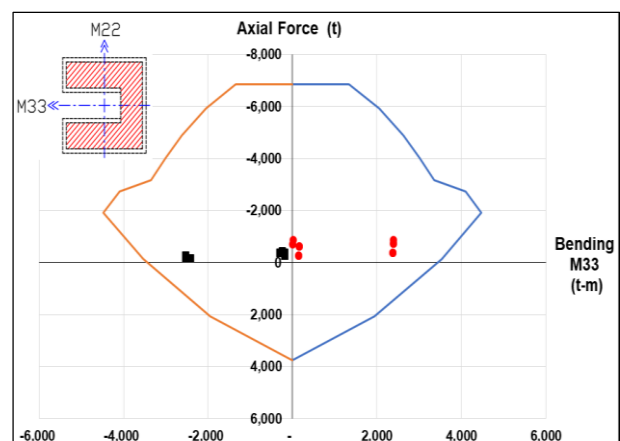
Under design loads, the structural elements of concrete beams and columns have larger capacity than their respectively demands, see Figure 18 and Figure 19 for axial – bending verification. However, there are only a few elements of beams and columns that fail due to bending and shear effects for load combinations that include combined dead, live and earthquake loads ($1.25DL + 1.25LL + 1E$ and $0.9DL + 1E$) including dead loads and live induced by the bridge crane when it is in operation with the full bucket, that is, it is expected that these elements fail when an earthquake occurs and the overhead cranes are in operation with full buckets. The faults that are expected in this event are shear failures for at C/6 and C/7 and B/6 and B7 columns and bending in the roof beams located between Axis A and B transverse direction. Slenderness and large displacement for columns are considered since they are carrying heavy gravity service loads out and large lateral displacements.

Figure 18. Diagram of interaction of column C-2R with jacket, axes C / 7 for levels from 0 to 10.50m (Source:Own)

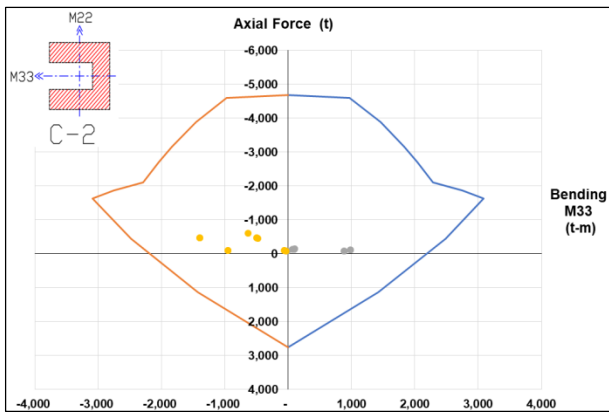
Spacing of stirrups on non-retrofitted columns and beams are larger than current provisions demand. Besides for shear capacity beams of 14m shows around 10% higher demand than capacity.

Figure 19. Diagram of interaction of column C-2 without jacket, axes C / 7 and C / 6 for levels from 10.50m to 21.00m. (Source:Own)

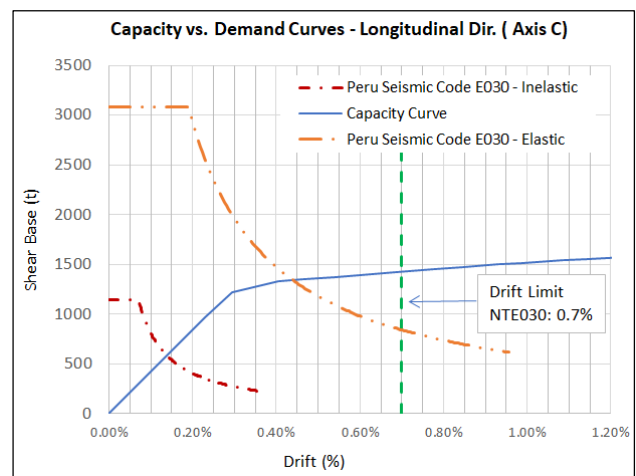
It can be seen in Figure 20 the performance response of frame at Axis C on longitudinal direction of the infrastructure. For drift response, it will develop in the non-linear range of behavior. This corresponds to the results obtained from dynamic linear analysis. By demand in bending, the frame of the Axis C would have an adequate behavior to an earthquake event like the one described, even so by cutting it has to be considered a reinforcement.

For shear base performance, the structure will be in a linear performance. It is observed that upon reaching the horizontal inelastic displacement limit of the seismic code, the structure would be in the non-linear range, where structural damage could occur such as cracking and spalling of cover, however it will not collapse and no major structural damage is expected.

Figure 20. Performance Points for Concrete frame Axis C (Source:Own)
