AUTOMATED POST-EARTHQUAKE PAVEMENT DAMAGE DETECTION USING DEEP LEARNING ON AERIAL DIGITAL IMAGES

Brigitte Puchoc^{1*}

¹ Centro Peruano Japonés de Investigaciones Sísmicas y Mitigación de Desastres, Universidad Nacional de Ingeniería, Lima, Perú

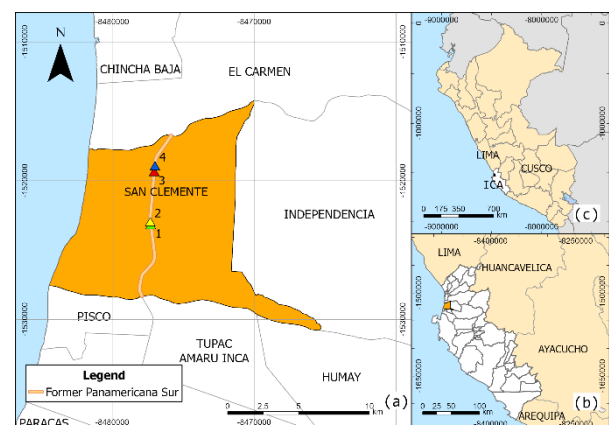
Fig. 1. (a) Study area: District of San Clemente, where the former Panamericana Sur passes through. The four colored markers indicate the locations of the historical aerial photographs used for analysis validation. (b) Location of the Ica Region within Peru, highlighting the province of Pisco and its connection to the capital city, Lima. (c) Reference map of Peru showing the position of Ica in the national context.

This research explores the potential of deep learning techniques as an alternative for automated post-earthquake pavement damage detection. The validation of the proposed approach is carried out using four historical aerial images captured over the district of San Clemente, an area of strategic importance as it encompasses the former Panamericana Sur highway, which connects Lima and Pisco [16], as illustrated in Fig. 1. This connection is particularly relevant given that Pisco was the region most severely affected by the earthquake. Moreover, San Clemente shares significant geographic and socio-economic ties with Pisco and plays a key role in the area's recovery efforts [16].

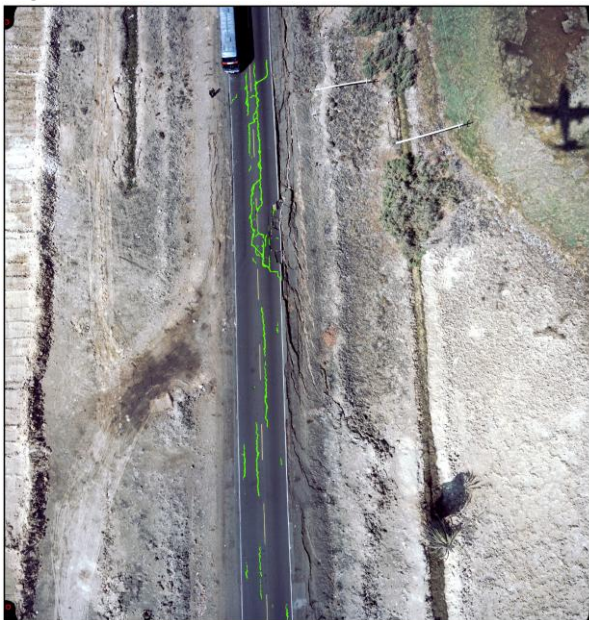
The DeepLabV3+ trained model was applied on four aerial imageries of earthquake-damaged pavement to assess its performance under post-disaster conditions. Fig. 8 presents the segmentation results, where cracks detected by the model are highlighted in green.

Fig. 8. Post-Earthquake Pavement Crack Detection Results.

The model effectively identifies major crack patterns along the damaged roadway, particularly in areas where pavement displacement is evident. A quantitative pixel-wise evaluation against a manually segmented reference resulted in an Intersection over Union (IoU) of 47.2%, a precision of 49.0%, and a recall of 93.1%, resulting in an F1-score of 64.3%. These results confirm that the model successfully detects most crack regions, but tends to over-segment them by generating masks that are visibly thicker than the actual cracks, see Fig. 9 This behavior increases the

The model effectively identifies major crack patterns along the damaged roadway, particularly in areas where pavement displacement is evident. However, some limitations were observed, including the incomplete detection of finer cracks and the misclassification of terrain irregularities as pavement damage. These errors arise from the high GSD of the post-earthquake imagery and variations in lighting conditions, both of which impact the segmentation accuracy. Another limitation of the proposed approach is that it is not fully automated, as it requires manual cropping of road areas from the full aerial images prior to inference.
