AUTOMATED POST-EARTHQUAKE PAVEMENT DAMAGE DETECTION USING DEEP LEARNING ON AERIAL DIGITAL IMAGES

¹ Centro Peruano Japonés de Investigaciones Sísmicas y Mitigación de Desastres, Universidad Nacional de Ingeniería, Lima, Perú

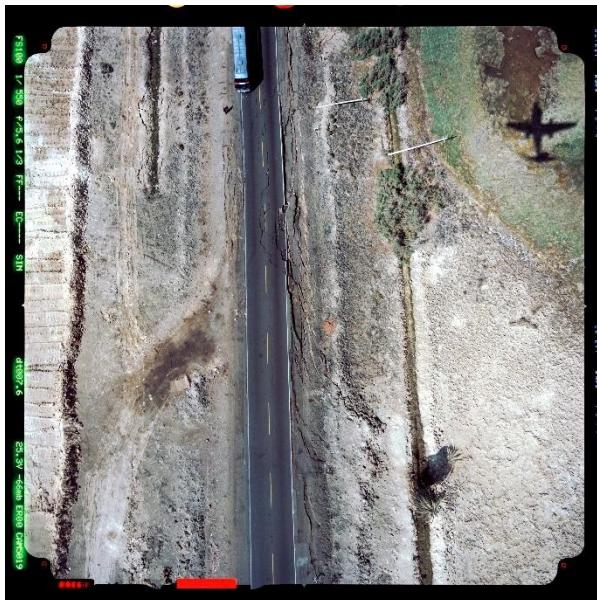
The trained model was applied in the aerial images obtained by the earthquake damage from 2007 Pisco Earthquake on the road former “Panamericana Sur” highway, representing data not included in the training dataset. These images, like presented in Fig. 6, were taken on August 17, 2007, at 2:00 PM approximately using an aircraft and has a resolution of 2870×2896 pixels with an approximate GSD of 4 cm/pixel.

Fig. 6. Image from former Panamericana Sur, Post-earthquake

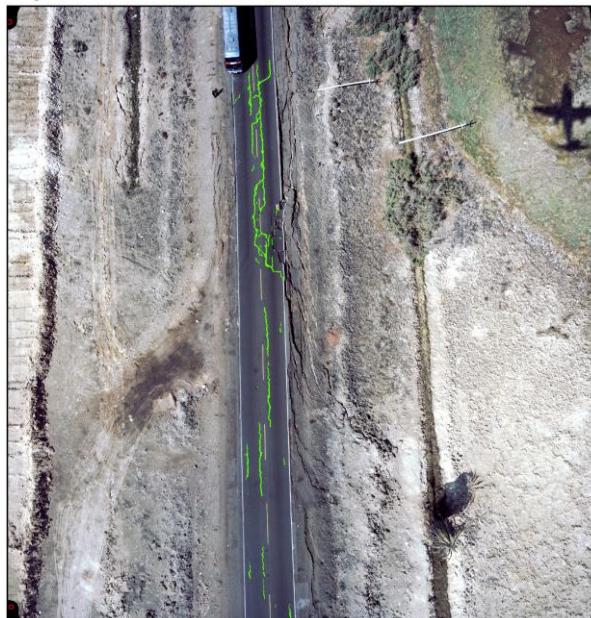
The DeepLabV3+ trained model was applied on four aerial imageries of earthquake-damaged pavement to assess its performance under post-disaster conditions. Fig. 8 presents the segmentation results, where cracks detected by the model are highlighted in green.

Fig. 8. Post-Earthquake Pavement Crack Detection Results.

The model effectively identifies major crack patterns along the damaged roadway, particularly in areas where pavement displacement is evident. A quantitative pixel-wise evaluation against a manually segmented reference resulted in an Intersection over Union (IoU) of 47.2%, a precision of 49.0%, and a recall of 93.1%, resulting in an F1-score of 64.3%. These results confirm that the model successfully detects most crack regions, but tends to over-segment them by generating masks that are visibly thicker than the actual cracks, see Fig. 9. This behavior increases the

The model effectively identifies major crack patterns along the damaged roadway, particularly in areas where pavement displacement is evident. However, some limitations were observed, including the incomplete detection of finer cracks and the misclassification of terrain irregularities as pavement damage. These errors arise from the high GSD of the post-earthquake imagery and variations in lighting conditions, both of which impact the segmentation accuracy. Another limitation of the proposed approach is that it is not fully automated, as it requires manual cropping of road areas from the full aerial images prior to inference.
