DAMAGE LIMIT STATES FOR CONFINED MASONRY WALLS BASED ON EXPERIMENTAL TEST

Carlos ZAVALA^{1,2}, Miguel DIAZ^{1,2*}, Erika FLORES^{1,2}, Lourdes CARDENAS²

¹ Civil Engineering Faculty, National University of Engineering, Lima, Peru.

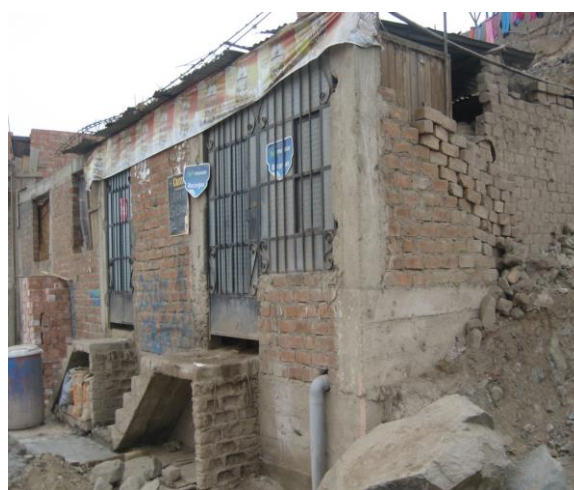
Figure 1. Non engineering confined masonry dwelling.

Therefore, the dwelling shows in Figure 1, represents housing in emerging urban areas on Lima city, usually on hill site. Another example of masonry dwelling are the houses which are located over non competent soils, such Lomo de Corvina area in southern Lima, show in Figure 2.

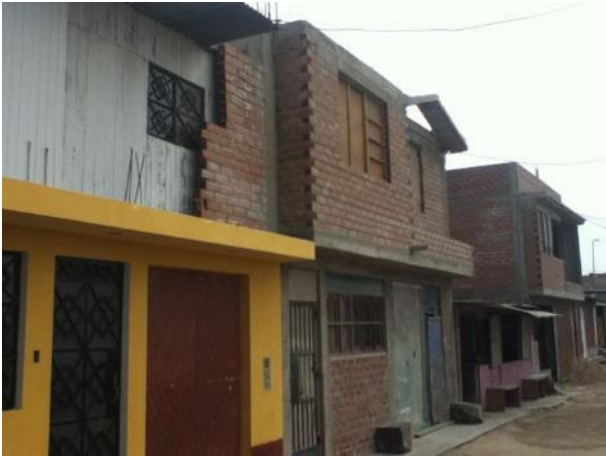
Figure 2. Tubular blocks on masonry dwelling

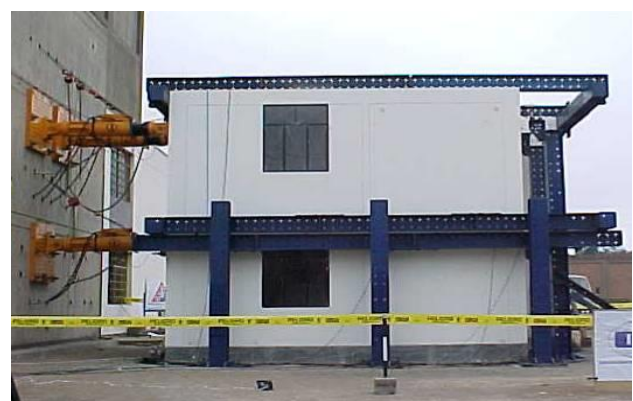
Figure 4. Full-scale test of masonry house [17]

Initial cracking of the specimen starts for a drift of 1/1600 with cracks of 0.05~0.10 mm. and become notorious after 1/800 when cracks of 1.2 mm. appeared. A maximum base shear 147.86 t. was the failure load of the specimen under a drift of 1/65 with cracks from side between 5~10 mm. in thickness.

In order to propose damage limit states from this real house experiment [17], the behavior curve is linked with the damage in each stage of the experiment. Using the same view presented in Figure 4, each of the stage mentioned in the above paragraph is show in the following figures.

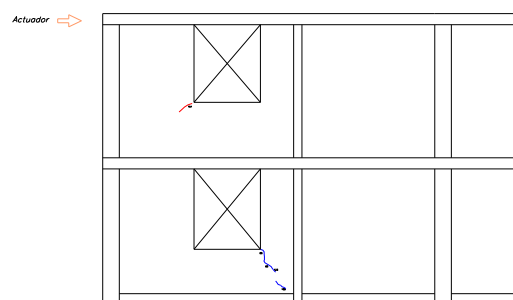
Figure 5: Damage state at 1/1600

The windows without join isolation is one of the more likely places where cracks start during earthquakes, therefore, during the experiment the first cracks appear around windows openings when drift reach 1/1600, with crack's thickness less than 0.5 mm. End of linear behavior is generated when cracks opening is over 1.0 mm and appears at on confined elements and cracks from windows reach these elements at drift of 1/800 and cracks appears on non-opening center wall. Here operation limit threshold is set on a drift range form zero to 1/1000 because from 1/1000 to 1/800 the reinforce bars on the vertical confine elements yields. In this range propagation of cracks on masonry walls and also cracking and confine elements shows the starting of deterioration on the structure. Therefore, this define the immediate operation state for the structure.

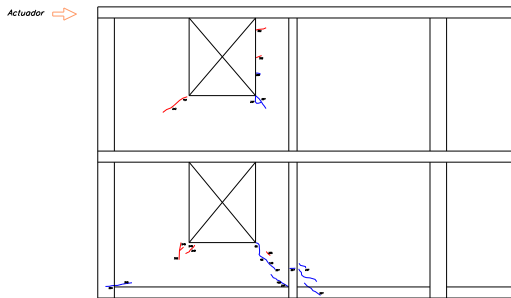
Figure 6: Damage state at 1/800

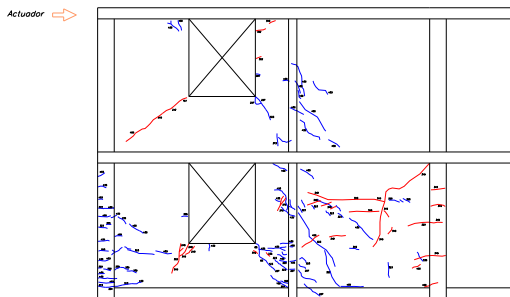
Figure 7: Damage state at 1/400

As mentioned before, non linear behavior and deterioration on the masonry walls started to be notorious in the drift range of 1/800 to 1/400, with cracks of 2 mm. but less than 4 mm, with a damage state as shown in Figure 7, here cracks on confined elements start to be notorious. Diagonal cracks started at drift 1/330 generating a state with diagonal cracks in both floors and both sides of the walls as is presented on Figure 8

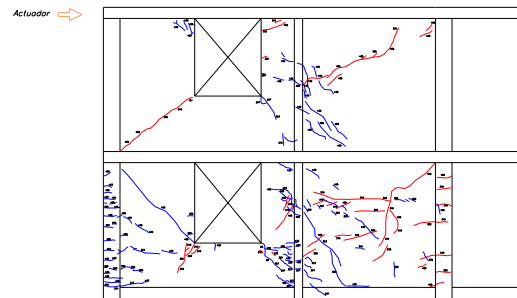
Figure 8: Damage state at 1/200

When drift of 1/200 is reached, glass on windows start to broken. In a real house it will be a risk for the occupants and by a drift of 1/150 is not save to be inside the house. Deterioration on confined elements with cracks on walls bigger than 6 mm. and also cracks of 2 mm. on confined elements, as is presented for 1/100 drift. Also at this stage windows and doors can not close due to the movement.

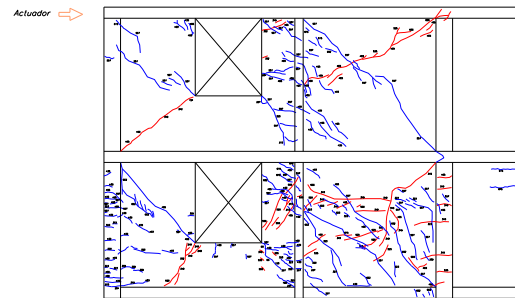
Figure 9: Damage state at 1/100

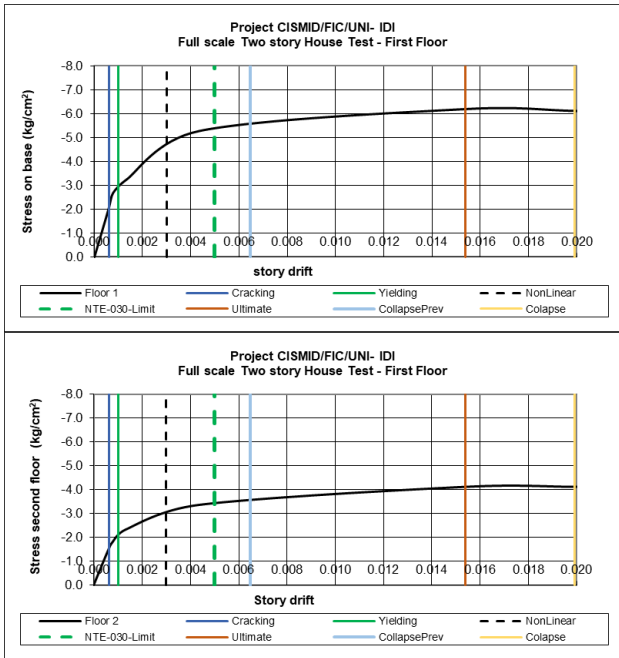
Figure 11: Damage states on behavior curve

Considering the results of the behavior curve [17] for the first and second floor express in terms of shear stress for each floor and drift values, limit state values are presented on Figure 11. Here the behavior presented previously on Figures 5 to 10, where the damage has been linked with the curves. Also limit values are shown in Table 1, where cracking drift, yielding drift, non linear representative drift, collapse prevention drift, ultimate capacity drift and collapse drift are presented. Here values are presented numerically and in fraction.

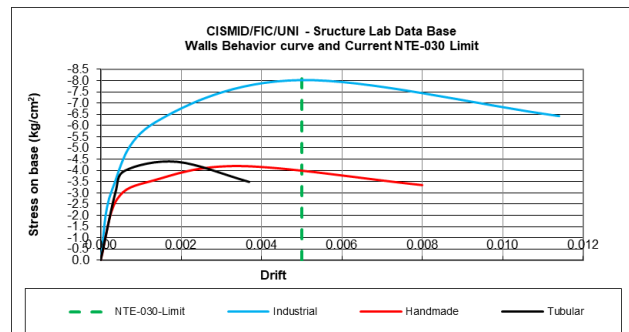
Figure 12: Behavior curve of three kinds of masonry

In the above figure it is possible to see the threshold limit value from the earthquake design standards NTE-E-030 for masonry buildings. This value is a threshold that divide the state of reparation of the building with the state of collapse or collapse prevention of the building. In the figure is possible to see that only the wall build with industrial solid brick meets the standards. Therefore, walls build with handmade brick and tubular brick have should be evaluate with different thresholds.

As was mentioned at item 2, Peruvian housing are build with different kinds of masonry walls, where near 82% of the housing buildings classify as non-engineering structures. Under this scenario during and earthquake the behavior of this walls will not be as retrofit limit from Masonry Standards NTE-E-070 and Earthquake design standard NTE-E-030 due to use of non-regulated masonry. Using data results form [1], [2],[3], [8],[10],[13] and [14], it is possible to consider the linearization of behavior curves from data base results and present 3 curves that represent the behavior of walls with industrial solid brick, walls with handmade brick, and walls with horizontal hollow brick also name tubular hollow bricks, presented in Figure 12.

In comparison with the other kinds of walls (Figure 12), capacity is higher than others and values meets the standards and can be consider the ideal wall. However more of the housing in the country are build with the other kinds of walls.

On Figure 15 behavior curve for wall build with tubular bricks is presented. As was shown in Figure 12, this type of wall is the lower in capacity due to the nature of its bricks with horizontal hollow. For this wall type, threshold of 1/590 is proposed with a value near the collapse prevention value.

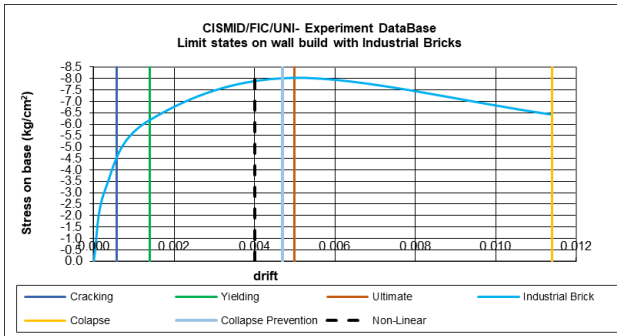
Figure 13: Damage states wall with industrial bricks

On Figure 13 the drift with stress behavior curve for wall build with industrial bricks is presented. In the figure limit values are presented, where each of the drift limit state are shown in Table 3. As was mentioned before, threshold of NTE-030 standards drift the curve just before the collapse prevention drift.

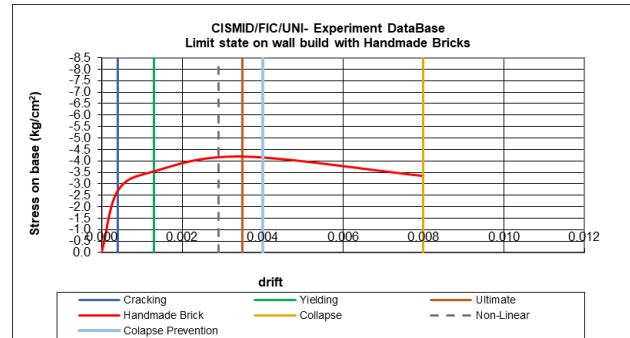
Figure 14: Damage states wall with handmade bricks

The wall with handmade bricks is likely used in emerging areas. These bricks are usually produced in small factories in artisanal way and sometimes are not well cook in artisanal oven. Therefore, capacity is presented in Figure 14 where limits are presented. Here the capacity is quite lower than industrial brick wall and standard threshold is not valid as presented in Figure 12. New threshold is proposed on this paper for this type of wall with a value of 1/300, show on Table 5, with a value between the nonlinear behavior limit and the collapse prevention limit

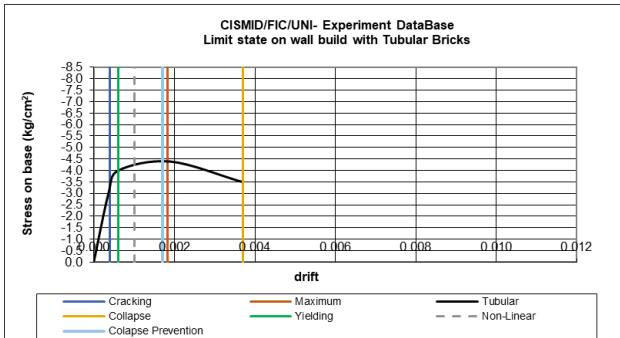
Figure 15: Damage states wall with tubular bricks

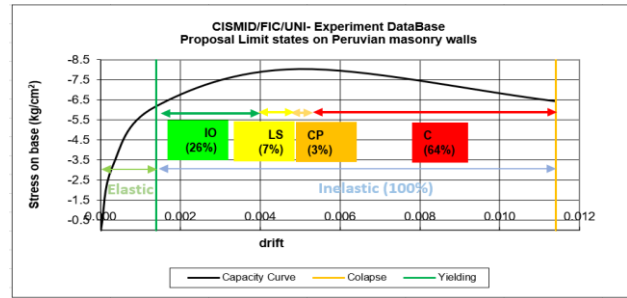
Figure 16: Damage states range example

To resume the damage state ranges and the use for earthquake analysis modeling, table 9 summarize the ranges for all the presented wall types. Figure 16 shows the use of this range for a capacity curve dividing the inelastic range in sub-ranges with each of the damage states and its applicability for modeling such push over analysis in order to find the performance of the structure for a demand spectrum with a target damping.

By the use of database of the structural laboratory of CISMID, the behavior curves for three types of masonry walls were presented, identifying the damage ranges (Table 9, Figure 16) and limit values (Table 3, Table 5 and Table 7). It is possible to read similar tendency in range of collapse (C) and collapse prevention (CP) and have different values on the other ranges. Also comparing the wall build with industrial brick and wall with handmade brick, has similar values for immediate occupancy (IO) and little bit less for life safety (LS).
