SEISMIC STRUCTURAL ASSESSMENT OF A 40 YEARS OLD MELT SHOP FACILITY

Guillermo HUACO^{1*}, Waldo INGA ¹, Audry CAMACHO²

² HATCH PERU, Lima, Peru.

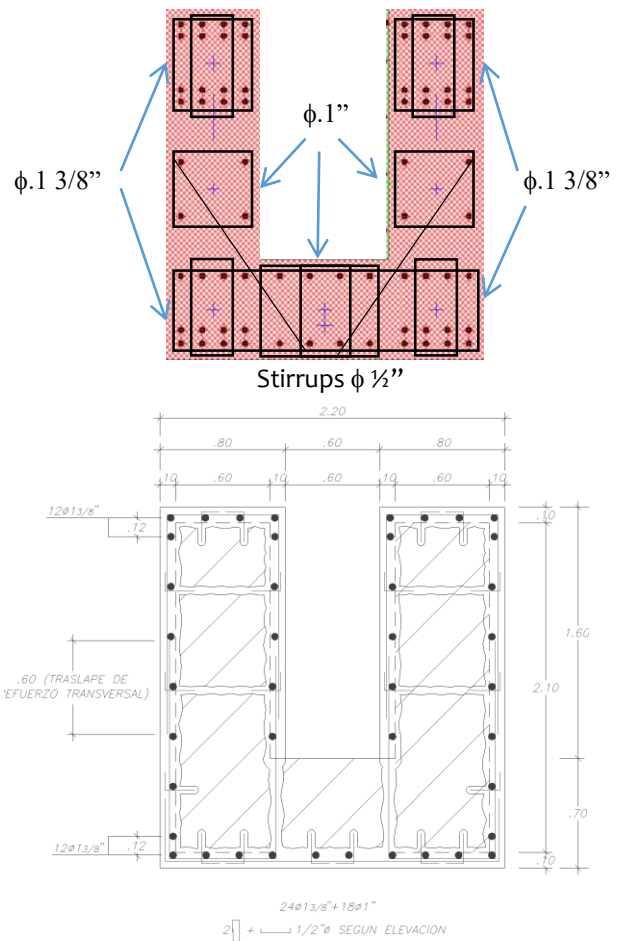
Figure 6. Concrete Column Reinforcement Details at Axis C. Original longitudinal reinforcement locating (above) and concrete jacket below (below)

Drawings made for the original construction were provided by the owner. It can be seeing C-shape columns of 60cm thickness and 2.10m x 2.40m base and deep section, as it can be seen in Figure 6, also the longitudinal and transversal reinforcement. Columns at Axis C and B between Axis 6 to 9 presents concrete jackets and the rest is original condition. Besides, dimensions of rail beams for the heaviest cranes are shown in Figure 7 and reinforcement in Figure 8.

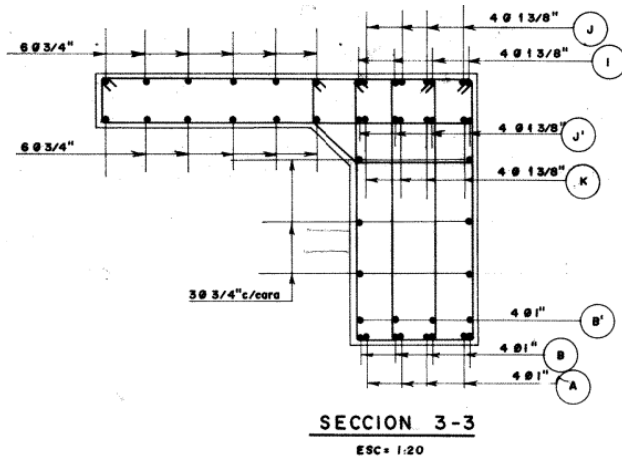
Figure 8. Internal reinforcement of rail beam Axis C

During auscultation of the reinforced concrete frames, the measurements of the original plans and the current condition of the element were observed and verified. It was found that some columns have cross sections with significant changes at half height (Figure 8), others with spalling of the cover, in addition to blows or possible friction caused by external agents (Figure 9), and total fall of coating and exposure of the internal reinforcement (Figure 10) which is rust can be noticed.

Considering the location near the sea, the moisture due environment, the loss of coating in the elements of reinforced concrete produces rust on the reinforcement, which along time can lose cross section and consequently its structural capacity will be reduced. For the structural analysis, the condition of the elements was taken account and the demand in the damaged elements was assessed.

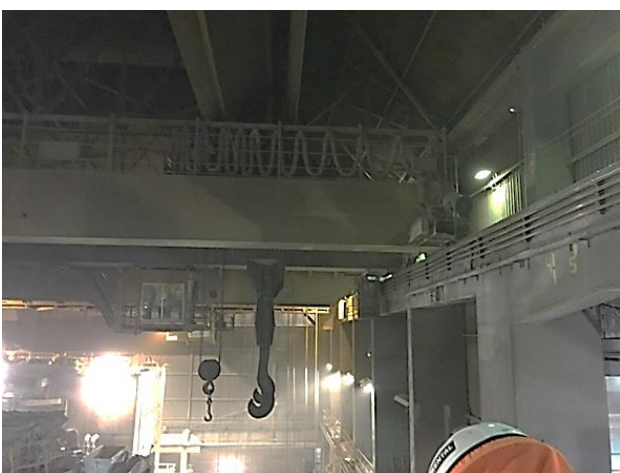
The reinforced concrete beams were screened to verify dimensions and conditions as well as observe how the loads and weights are transmitted from their origin to their foundation. It can be seen in Figure 11 the overhead crane supported on the rail beam of the C axis and the 130t crane.

Figure 11. View of the C-shape rail beam Level +21.00 which is support of the 130t load crane. (Source:Own)
